## EXPLOITATION REPORT

3. FRAGMENT, METAL, RECOVERED IN THE REPUBLIC OF THE CONGO,  
 BELIEVED TO BE AN UNIDENTIFIED FLYING OBJECT  
 (COUNTRY UNIDENTIFIED) (U)  
 PXN-25500

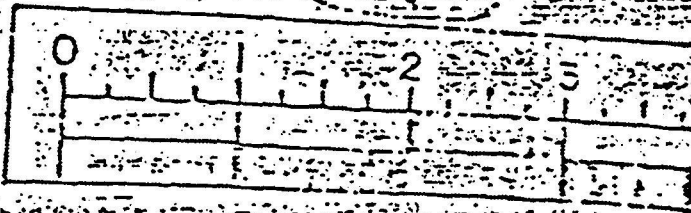
Figure 1. Top View of 265-41

2. (C) Details concerning the exact location and characteristics of impact are unknown. However, the appearance of the fragment indicated exposure to high temperatures prior to impact (burn). Impact of the specimen had little or no effect on its final condition or appearance. The fragment weighed 26.1g, had an indefinite density of approximately iron and measured  $2.25 \times 1.75 \times 1.0$  inches. The top and side views of the specimen were rounded and appeared to have been shaped by heating and melting. This is illustrated in Figures 1 and 2. The V-shaped groove, visible in Figure 1, is the outline of an insert of steel that differs materially from the rest of the specimen. Figure 3 shows the side view of the end shown in Figure 1.

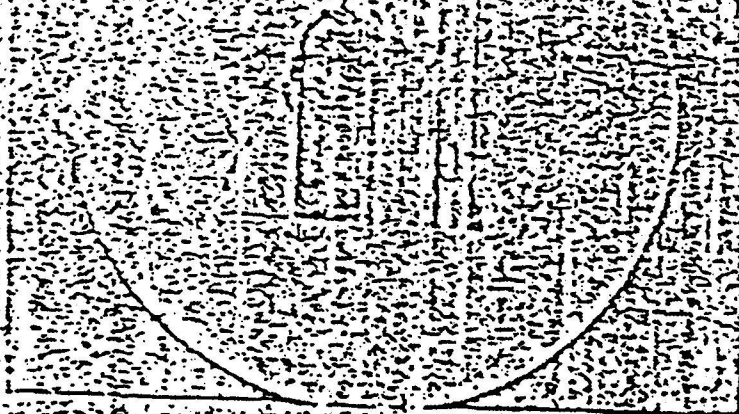
Figure 4. Opposite View of Fig. 1 (b)

7. (C) The recovered specimen weighed 41 grams and had a density closely approximating that of steel. The specimen, when subjected to heavy oxide was found to have been exposed to temperatures in excess of 2500° F. While there are no indications of impact, the sieved metal, as shown in Figures 4 and 7, would substantiate the conclusion that the item was moving at a high velocity when it was shot.

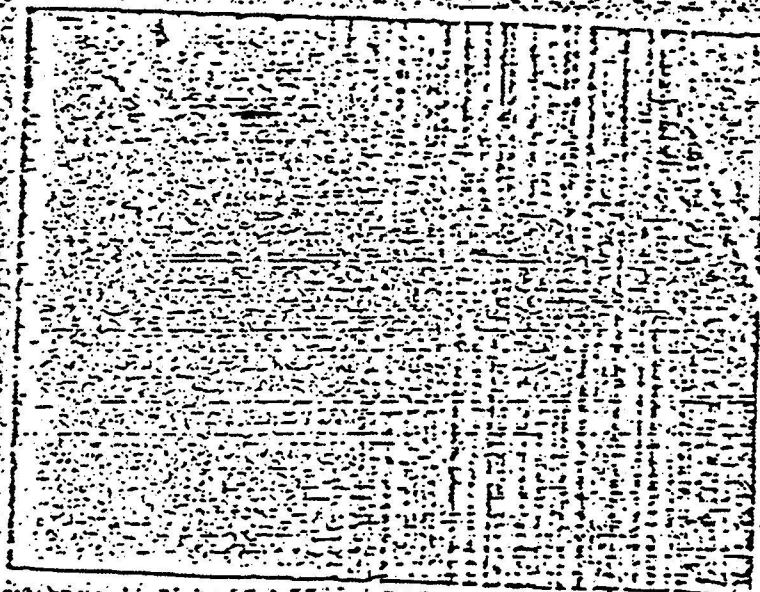
Figure 7. Micrograph Cross Section of  
Laminated Area  
Magnification 2,750X (U)

10. (C) The lamination or stacking of individual laminates is clearly illustrated in Figure 5. The space between laminates on the fin at the top of the photograph is due to the melting and flowing of the copper during the high temperature exposure of the specimen. Some of the copper has been removed at the fin at the bottom of the photograph. A cross-section of this area is shown in Figures 7 and 8.

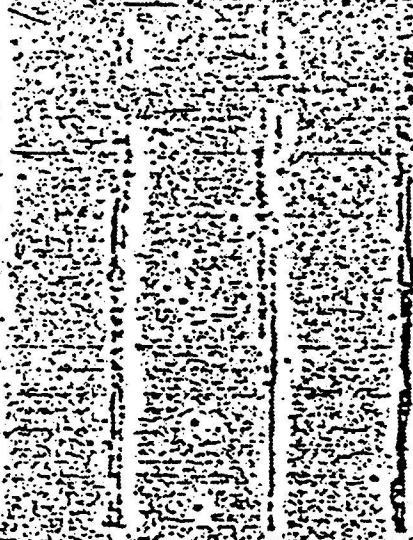
Figure 9 (a) Mirror Image  
of the Object  
Magnification 6x  
(3x Nitral Etcher)

12. (C) The light material between the laminations in Figure 9 is plated copper that melted and flowed between the laminations when the entire specimen was hot. A photomicrograph of this is shown in Figure 11.
